NRL Report 8370

**Fractographic and Microstructural
Analysis of SCC Specimens of HY-100, HY-130,
and HY-180 Steel Weldments**

FRANCES W. FRASER AND EDWARD A. METZBOWER

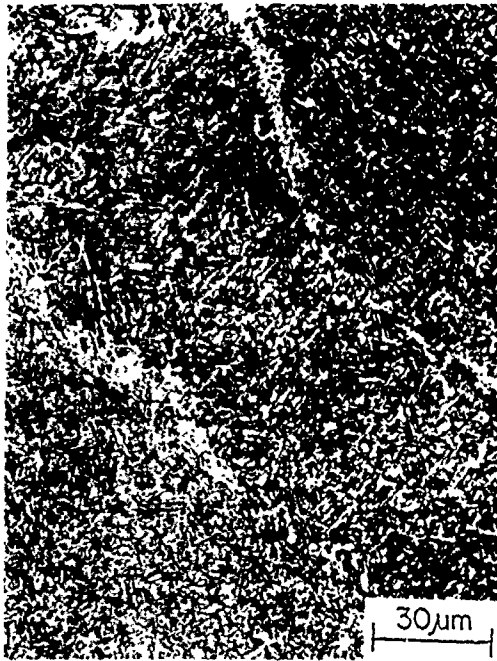
The microstructure of each specimen was predominantly a mixture of ferrite and either bainite or baintic ferrite and carbides. The ferrite morphology in specimen A was largely acicular, and a network, or vein, of ferrite was found along some grain boundaries (Fig. 4a). Also, the ferrite morphology in some areas resembled a Widmanstätten structure, and strings of enlarged, spheroidal particles were found along prior austenite grain boundaries (Fig. 4b). In specimen Z the microstructure was relatively fine and uniform (Fig. 5) with no evidence of a ferritic network at the grain boundaries. Secondary cracks, extending from the fracture edge into the microstructure, were prominent in specimen A but not in specimen Z. Grain-boundary separation, and the generally coarse texture of the columnar grain areas on the fracture surface of specimen A, probably resulted from cleavage of the ferritic networks.

Fig. 4a — Ferrite veins at grain boundaries in specimen A

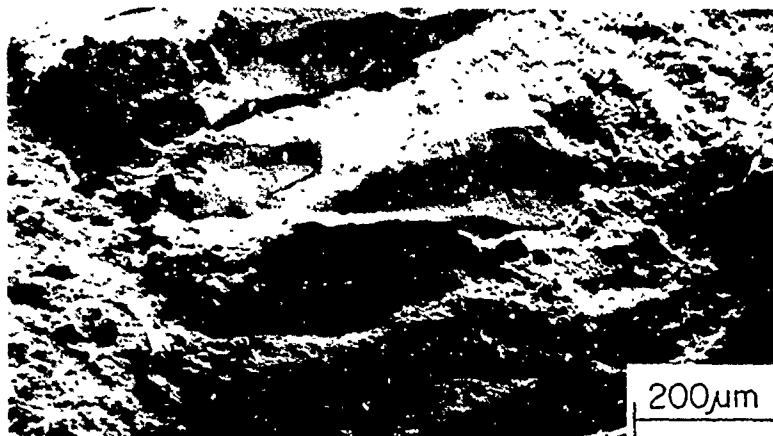
Fig. 14a — Intergranular separation in columnar grains in specimen K

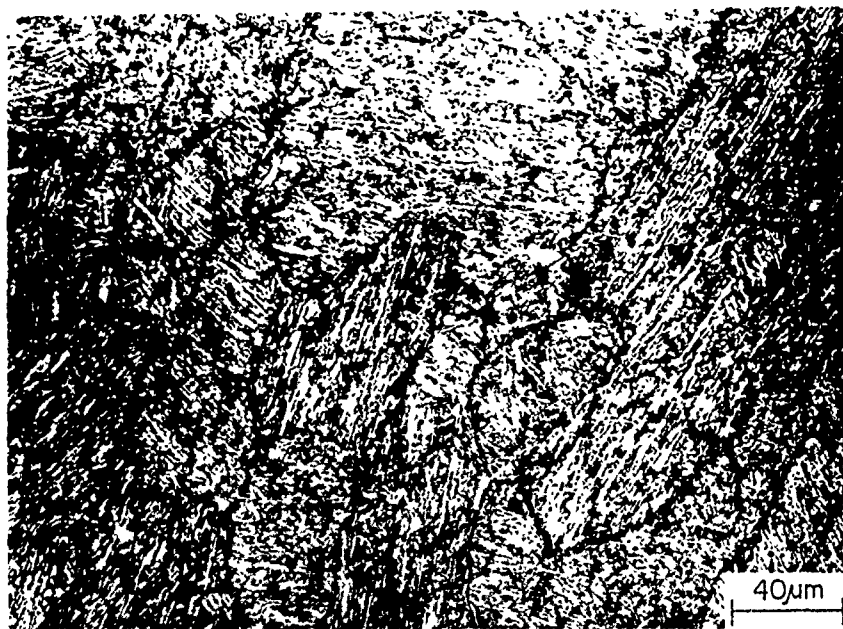
The microstructure consisted of martensite, acicular ferrite, and bainite. Ferrite platelets, along with clusters of precipitates, formed at the boundaries of the more equiaxed grains (Fig. 19). Strings of precipitates and microcracks were found along columnar grain boundaries.

Fig. 19 — Microstructure showing ferrite platelets and precipitates along grain boundaries in specimen L

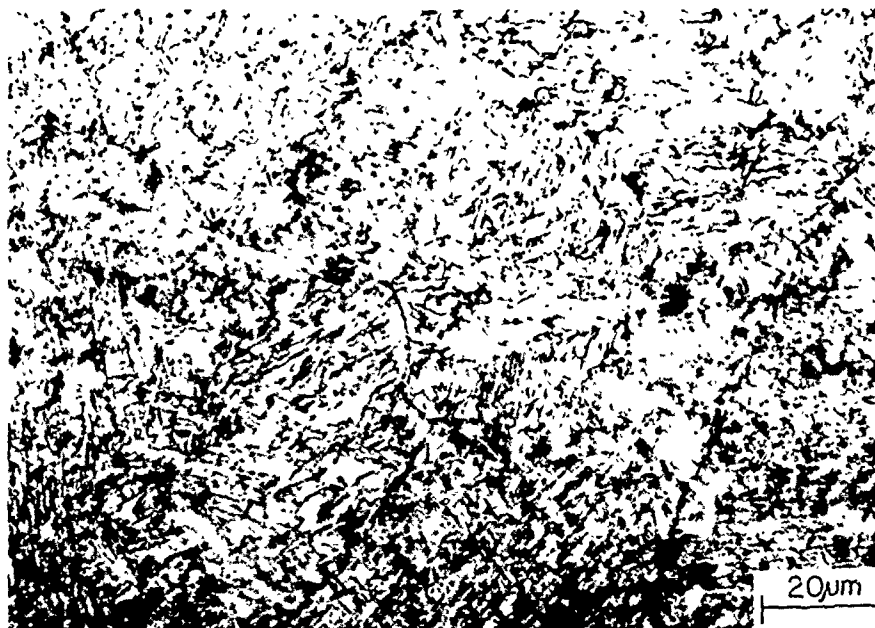
Fig. 22a — Acicular ferrite, bainite, and martensite in specimen R

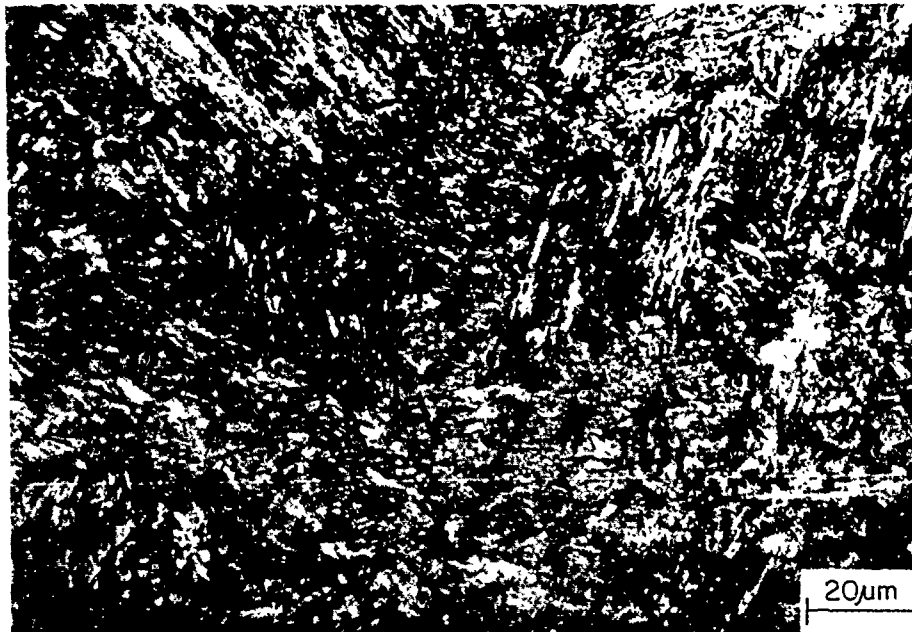
A uniform microstructure of tempered martensite with a hardness of 46.6 R_c was found along the fracture edge in the longitudinal section of specimen J (Fig. 31). The microstructures of the heat-treated specimens, specimens Q and H, were similar in appearance to that of the grain-boundary phase in specimen I (Figs. 32 and 33). Specimen Q contained light and dark etched areas with hardnesses of 49.3 R_c and 48.1 R_c respectively. The microstructure of the overtempered specimen, specimen H, was finer than that of Q and considerably softer, with a hardness of 39.1 R_c .

Fig. 31 — Tempered martensitic microstructure in specimen J
